Technical Bulletin

Bulletin No. 005 Rev B

Multiple Station LED's Illuminated but Stations Do Subject:

Product Applicability: Evolution DX2 Controller

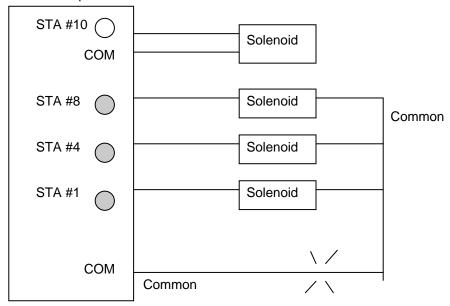
Controller Station Output Board

The solenoids are connected to station outputs 1, 4, and 8 with one common return line to the station output board. Station #10 does not share the common return line of stations 1, 4, and 8.

When station one turns on, 24 VAC is applied to the station output and the LED illuminates. If the common line is broken or open, (as shown by the cross marks) current does not flow and the solenoid is not energized. However, a small amount of current flows through the solenoid coils back to each station output LED. This causes the station LED's #4, and #8 to illuminate, creating the illusion that the stations are on. This unstable condition can cause unpredictable operation of the associated solenoids, which may or may not become energized.

If a zone does not water but that station's red LED light turns on as well as other various LED's for other stations, the field common wire for those stations is likely not connected to the controller (floating). Check the field wiring common connection at the controller and at the field junction where they may be tied together. Check for continuity of the common line from the controller to the field valve.
